# Aqua Lung America **TECHNICAL BULLETIN**

April 4, 2006  
No. 17

## **SUBJECT: Apeks Second Stage Diaphragms**

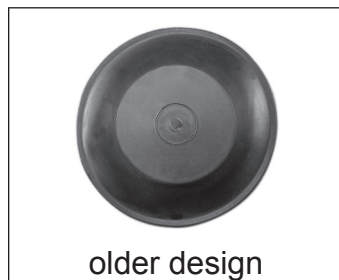
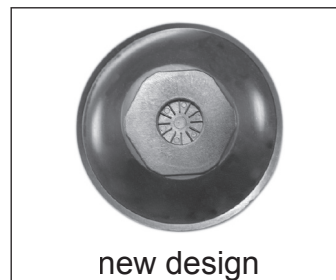
Aqua Lung has received limited reports of distortion to the second stage diaphragm (p/n's AP5803 & AP2023) on the Apeks ATX and TX line of regulators.

The problem has been traced to ozone exposures at higher than normal levels. When exposed to high levels of ozone the diaphragms could distort and shrink in size. This distortion will not cause a problem with a regulator currently in service as the diaphragm is held securely in place and cannot be dislodged.

During annual service, inspect the diaphragm for any signs of distortion. If there are no signs of distortion the diaphragm is safe to reuse.

If a diaphragm is seen to be distorted it must be replaced by the current diaphragm design . If there is any doubt, the older diaphragm design should not be reused.

Both models of diaphragms (AP5803 & AP2023) have been redesigned using improved materials.
